Delayed spinal cord injury following microchip placement in a dog

Supplementary files: Original images from paper, which were printed in greyscale, shown in full-colour.

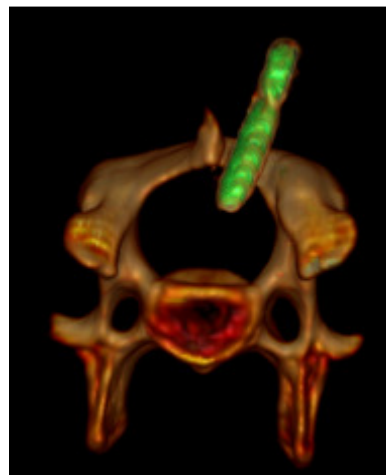
Fig. 4 Volume-rendered, three-dimensional cranial projection of the computed tomographic study of the sixth cervical vertebra. The image shows the green (metallic) foreign body protruding into the vertebral canal.
